# Gregg Lake Action Plan

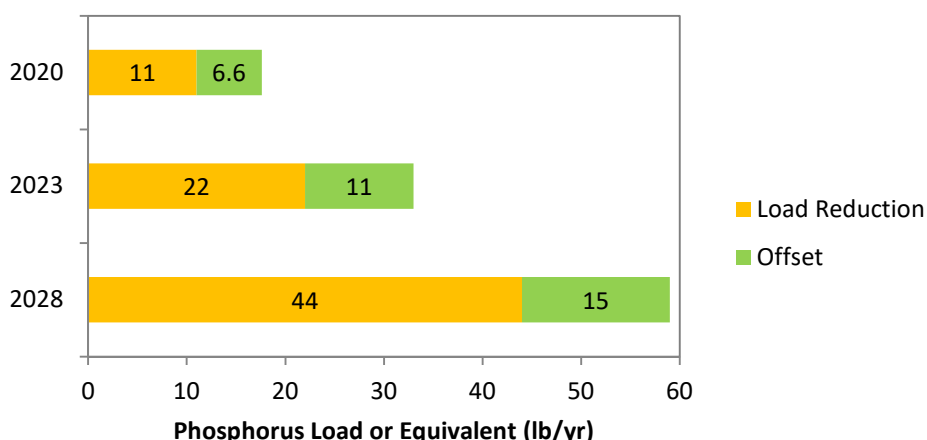
**Figure 2.1.** Cumulative phosphorus load reduction goals over the course of the ten-year WMP, with interim goals in 2020 and 2023. Goals were set to reduce amounts of total phosphorus entering Gregg Lake (Load Reduction) and to offset phosphorus loading through conservation easements and zoning and ordinance changes to encourage low-impact development (Offset).

A watershed management plan (WMP) is intended to be a ten-year plan to restore and preserve water quality. To effect a 23% reduction in phosphorus loading over ten years, with concomitant reductions in sediment and nitrogen loading, FBE calculated that we would need to reduce phosphorus (TP) loading by a total of 44 lb/yr, combined with an offset of 15 lb/yr through conservation easements and adoption of regulations to encourage low-impact development. Calculations were performed with 2028 as the endpoint for the WMP, and interim goals were set for 2020 and 2023 (Fig. 2.1).

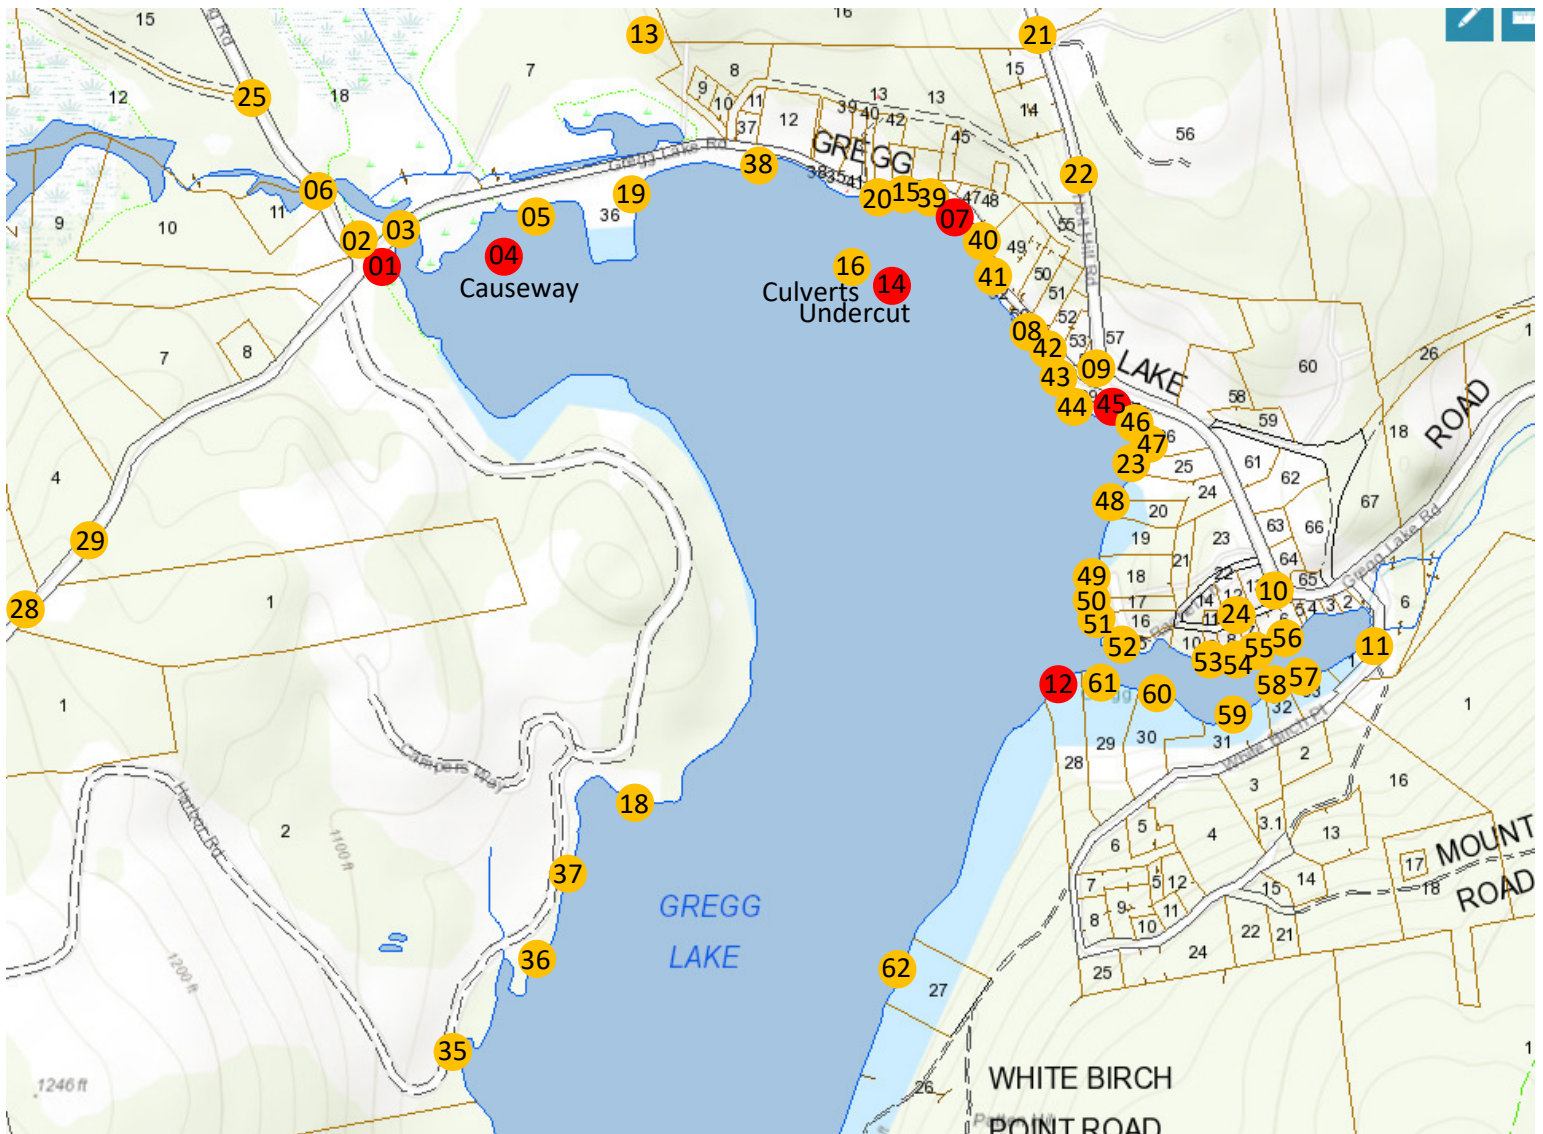
**Figure 3.1.** Erosion “hotspots” identified in the Gregg Lake watershed in the vicinity of the northern part of the lake. Locations classified as “high impact” (red dots) were estimated to cause phosphorus loading in the range of 1.5–2.5 lb/yr, whereas “medium impact” sites (orange dots) were estimated to supply 0.1–1.5 lb/yr. Sites 1–31 were evaluated by FBE for pollutant loads; sites 32–63 were rated by comparison with FBE’s assignments.

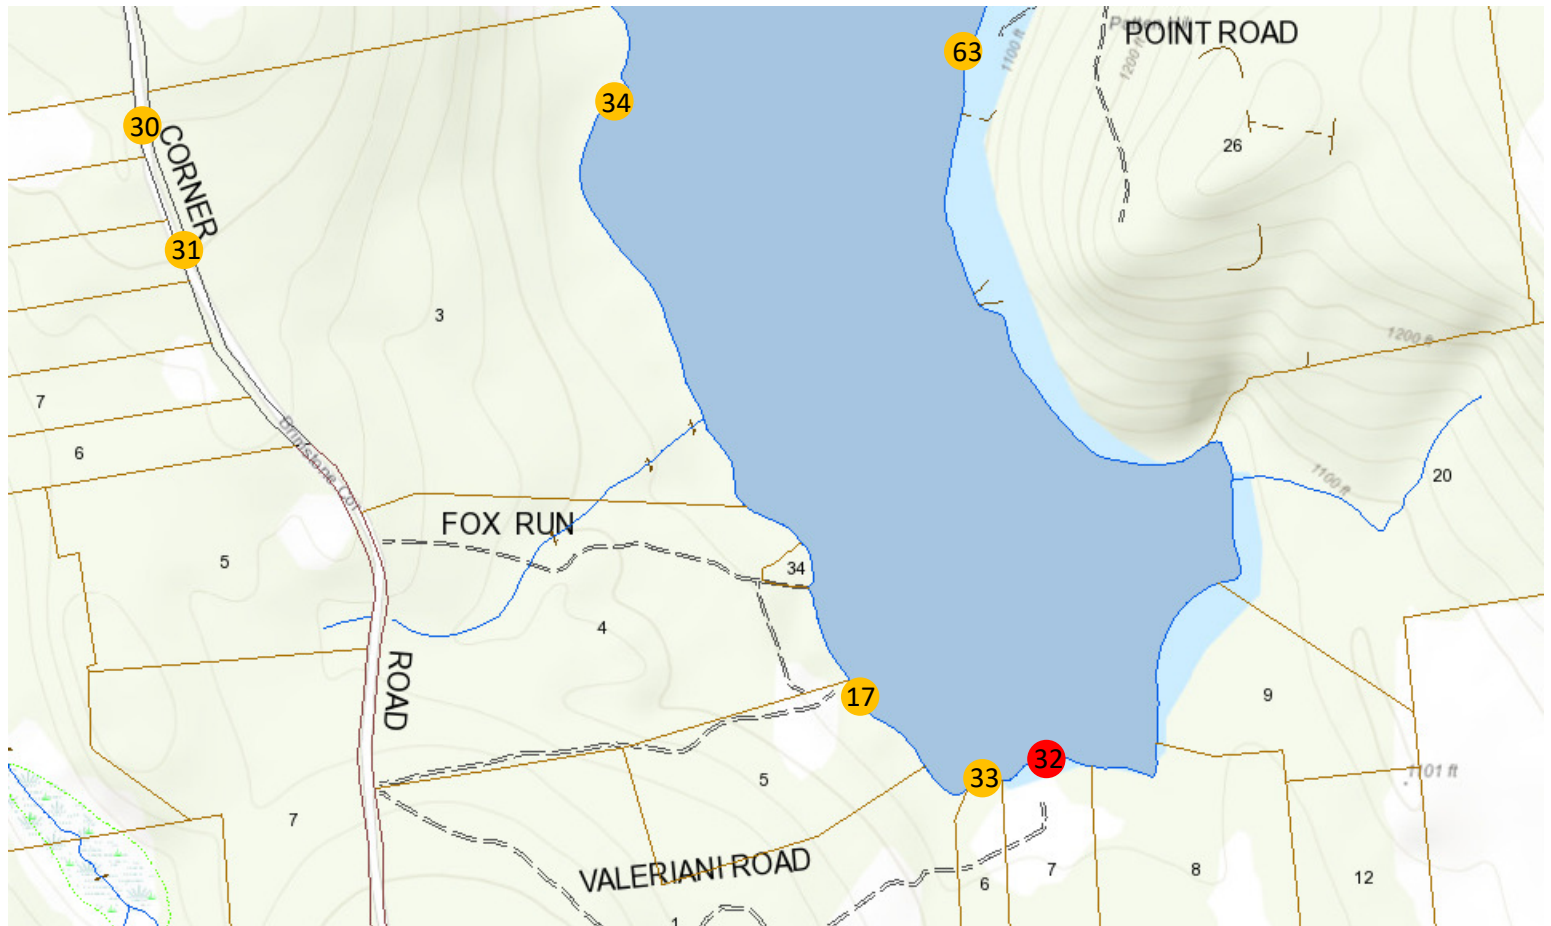
**Figure 3.2.** Erosion “hotspots” identified in the Gregg Lake watershed in the vicinity of the southern part of the lake. Locations classified as “high impact” (red dots) were estimated to cause phosphorus loading in the range of 1.5–2.5 lb/yr, whereas “medium impact” sites (orange dots) were estimated to supply 0.1–1.5 lb/yr. Sites 1–31 were evaluated by FBE for pollutant loads; sites 32–63 were rated by comparison with FBE’s assignments.

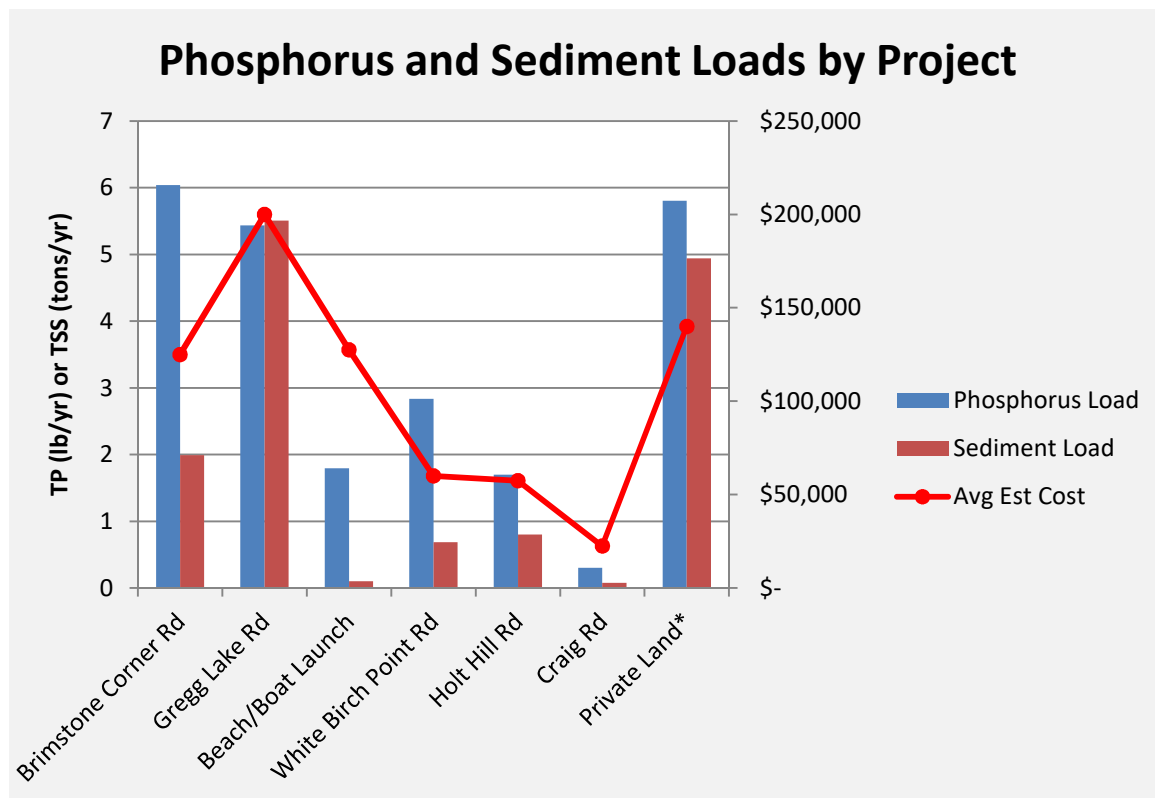
**Figure 4.1.** Phosphorus and sediment loads and average estimated costs for Gregg Lake erosion sites bundled into project areas. TP, total phosphorus; TSS, total suspended sediments.

Phosphorus load reductions for the bundled projects were estimated, along with sediment load reductions and average estimated costs (Table 4.8, Fig. 4.1). The total phosphorus load reductions added up to approximately 24 lb/yr, well below the target of a 44-lb/yr phosphorus load reduction by 2028.

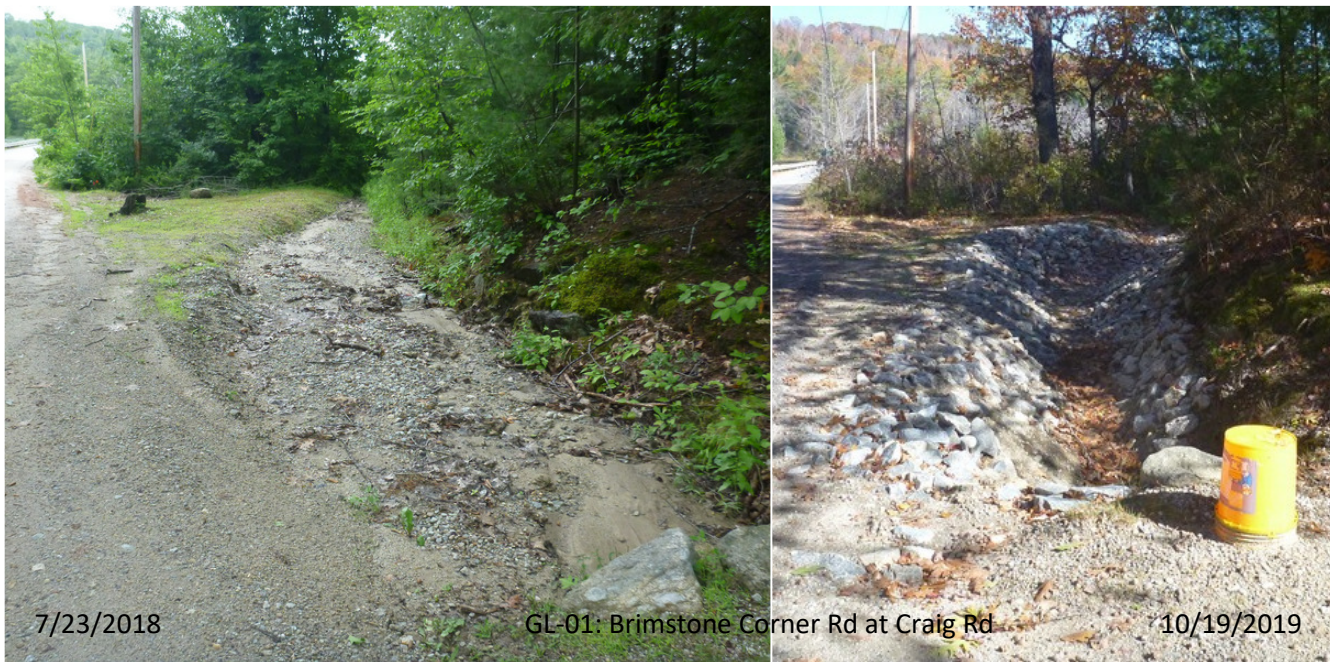
**Figure 5.1.** Erosion Site 01 at the intersection of Brimstone Corner Road, Craig Road and Gregg Lake Road, where stormwater runoff carries sediment down a steep section of Brimstone Corner Road and deposits it directly into Gregg Lake. Photos taken at the outlet of the culvert under Harbor Road looking towards Gregg Lake before (left) and after (right) installation of uphill turnouts and diversion dams, lining ditches, crowning, stabilizing road shoulders and installing a catch basin.

The main challenge to completing the Brimstone Corner Road project is scheduling Antrim Highway Department time. The Highway Department began work on the project in Fall 2019 (Fig. 5.1), and will continue in 2020.

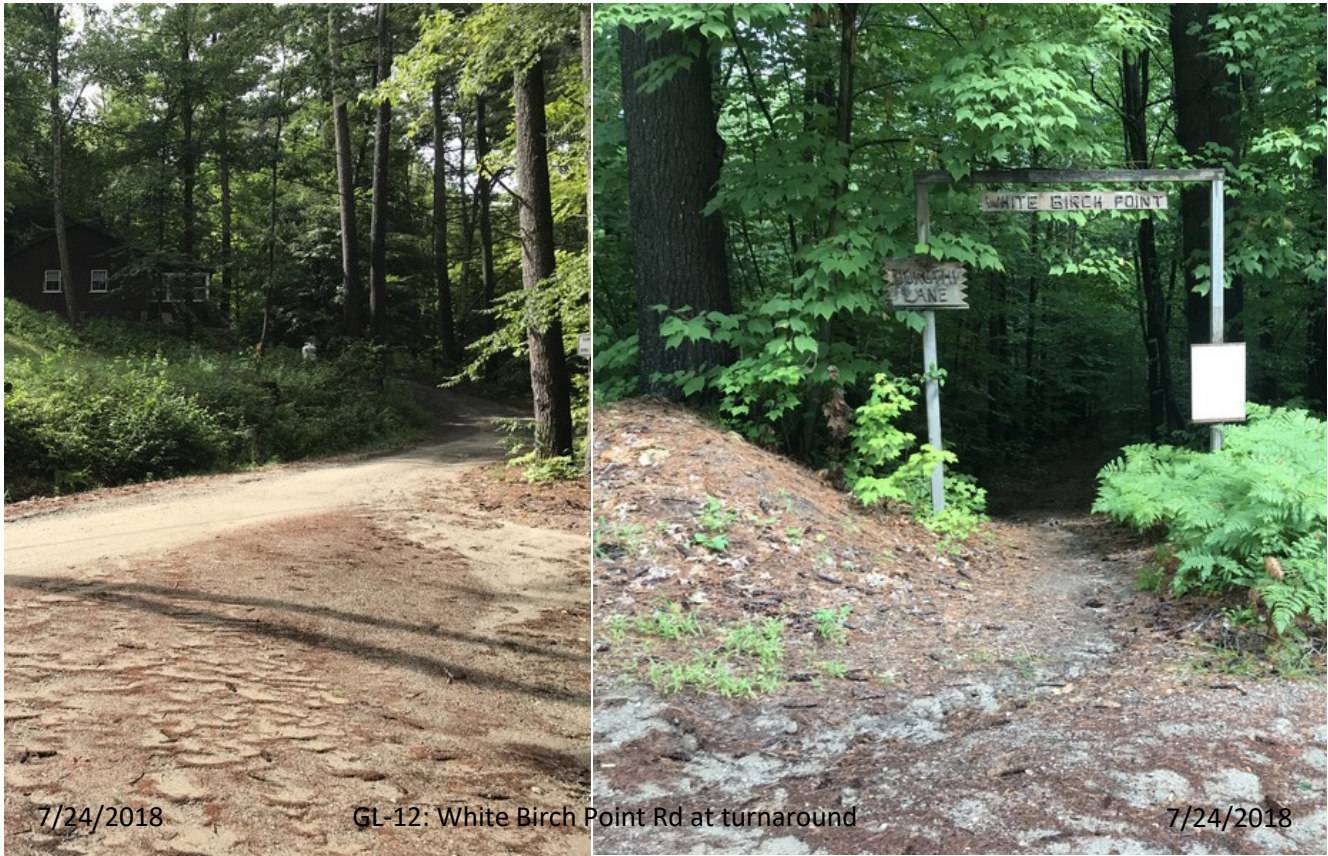
**Figure 5.2.** Erosion Site 12, where stormwater runoff from the upper section of White Birch Point Road flows across the turnout (left) and enters the steep access road to the White Birch Point private beach (right) or an adjacent private driveway.

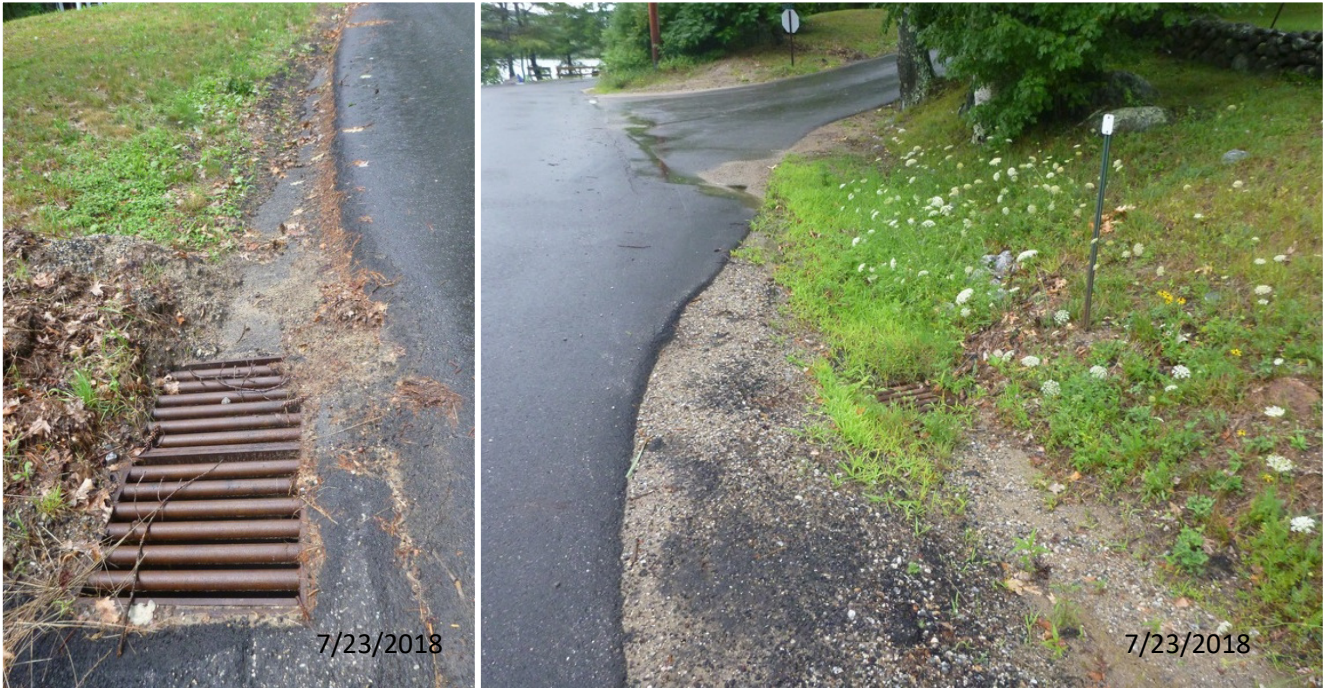
**Figure 5.3.** Erosion Site 09, where stormwater flows down Holt Hill Road, crosses Gregg Lake Road and washes across private beaches to enter Gregg Lake. A recently-constructed catch basin directs some of the flow under the road (left). Suggested area for installing a catch basin for remaining flow directed across Holt Hill Road, with storm drain in place (right). Ditch maintenance will be increased as needed to retain sediment.

In addition to stabilizing the road shoulder and armoring ditches, the recommendation from our consulting engineers (HWG) is to install a water bar to divert remaining water flow from South Holt Hill Road into an infiltration basin on the east side of the road. There may be adequate space to install a catch basin within the road right-of-way. If not, an easement from the land owner may have to be sought. Runoff will be monitored to see how much private beach erosion continues to take place. Further work on Holt Hill Road will be scheduled to begin in 2025.

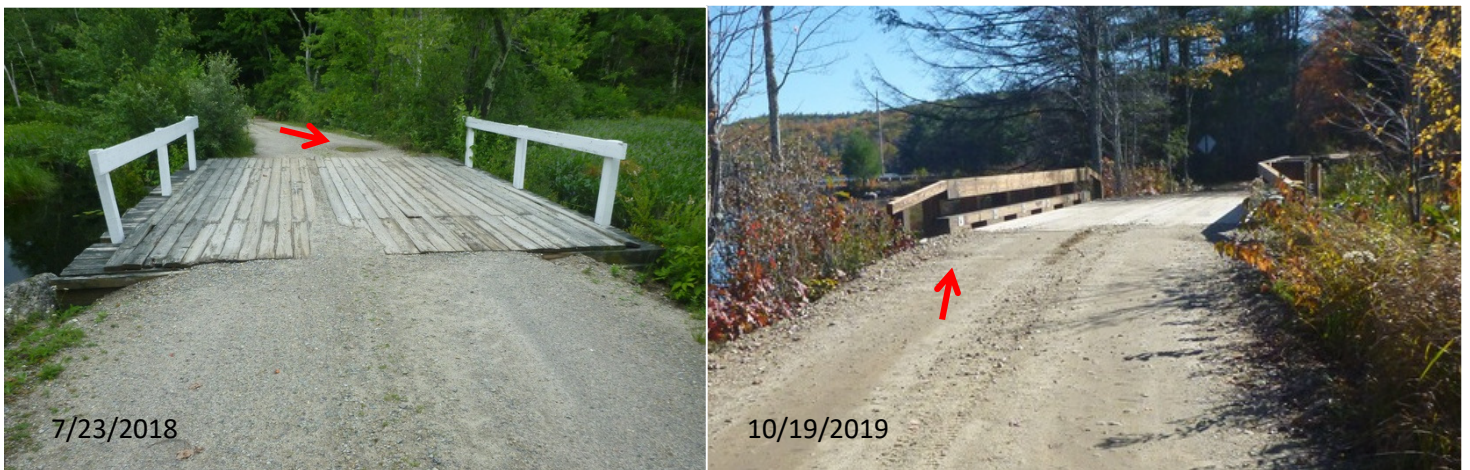
**Figure 5.4.** Left: Erosion Site 06 viewed from the south, showing severe erosion of Craig Road causeway and bridge shoulders, high water level on west (left) side of bridge due to beaver dam underneath and location of filled sinkhole, which had opened up in 2018 (arrow). Right: Site 06 viewed from the north, after bridge replacement. Sinkhole location still visible (arrow).

At the time of the initial survey in July, 2018, severe erosion was evident around the Craig Road Bridge (Fig. 5.4). Water levels were also high due to beaver dams under both the Craig Road bridge and the Gregg Lake Road bridge. A sinkhole had opened up near the north side of the bridge in 2018. The Craig Road bridge was replaced in Spring 2019. An additional erosion site was identified at the intersection of Hattie Brown Road and Craig Road.

It is likely that high water levels have caused stress on both sides of the Craig Road causeway, as evidenced by sinkholes and shoulder erosion. The beaver dam under the Craig Road bridge was removed for construction of the new bridge, but the beavers had begun to rebuild by mid-summer (Fig. 5.5). Given the sinkhole formation and shoulder and bank erosion, beaver control devices should be installed under the Craig Road bridge to minimize the rise of water levels.

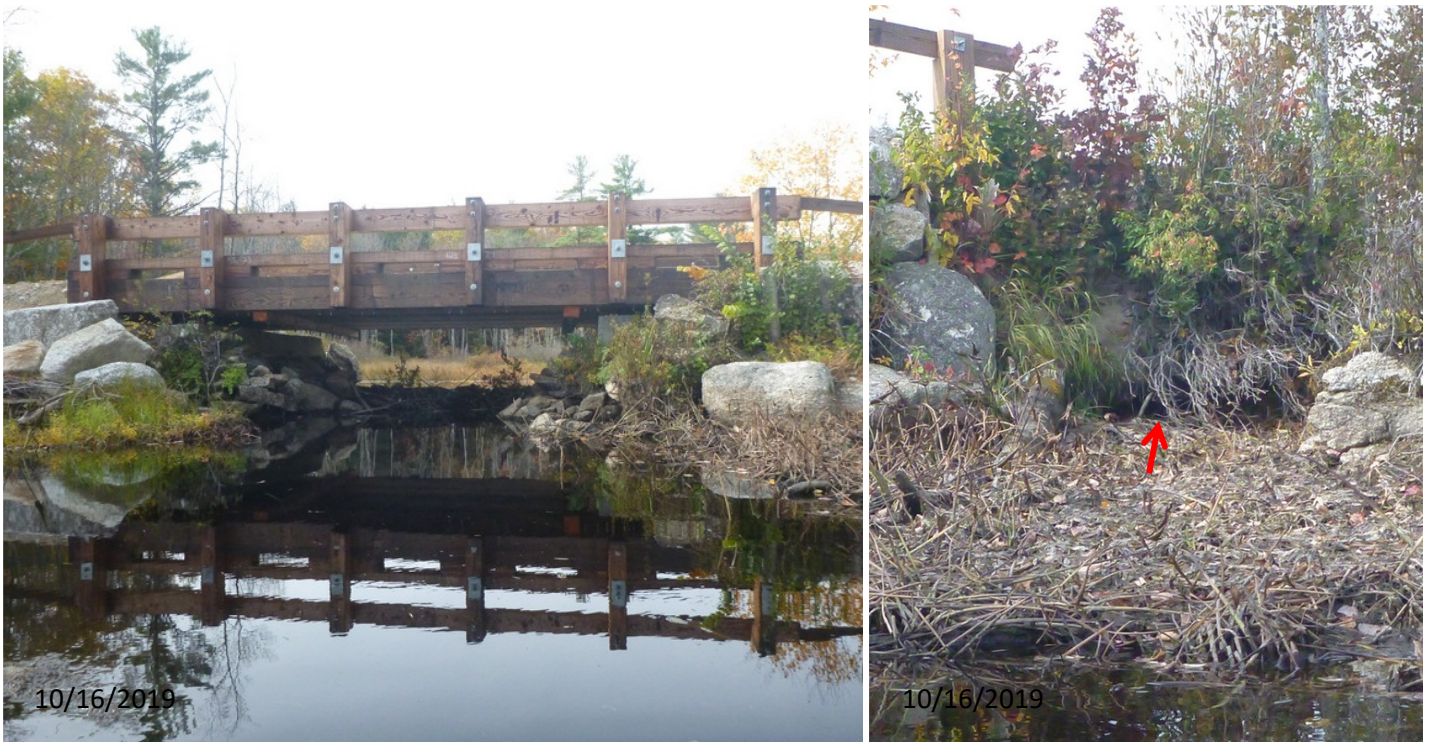
**Figure 5.5.** Beaver dam under new Craig Road bridge (left), with downstream water level lowered by approximately 16 inches after removal of flash boards at Gregg Lake dam. Bank erosion and probable sinkhole drainage site (arrow) at high water level made visible by low water level.

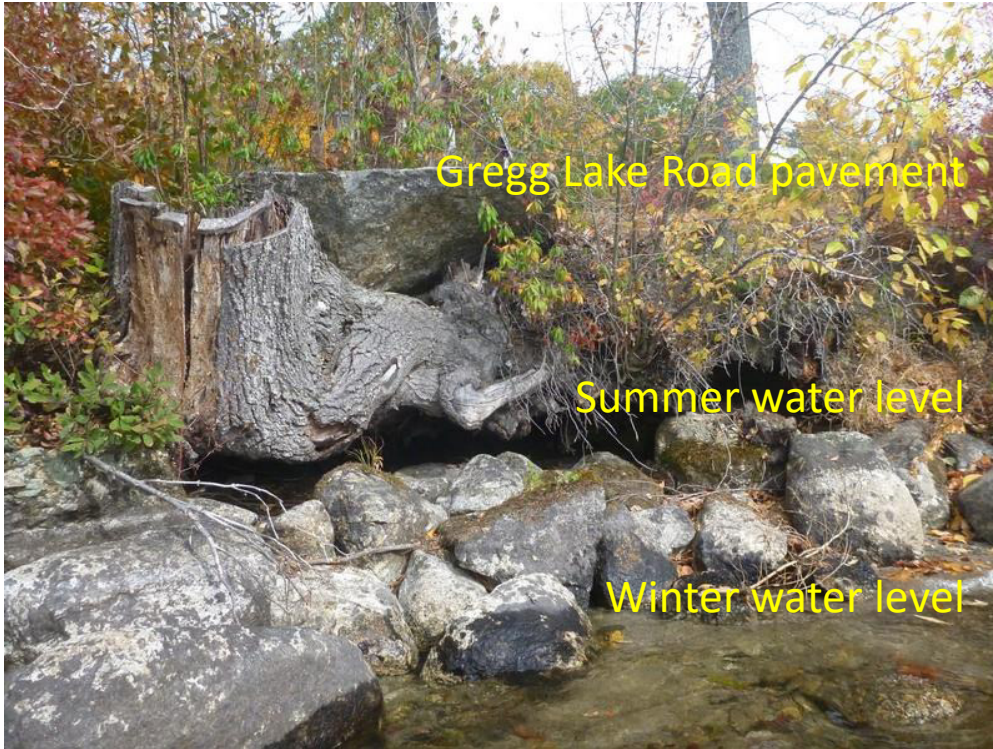
**Figure 5.6.** Undercut of bank close to Gregg Lake Road at summer water level. Photo taken with water at winter level, with both flash boards removed and water just flowing over dam.

Since the Gregg Lake dam was rebuilt in 1982, the lake level has been kept consistently higher than it ever was in the past. Erosion in many areas shows that a new shoreline is being established. This erosion is severe for a stretch of about 2,000 feet along Gregg Lake Road, where in several spots the bank undercut at the summer water level reaches close to, if not under, the road pavement (Fig. 5.6). The land on the lake side of the road from near the dam to the public beach is privately owned.

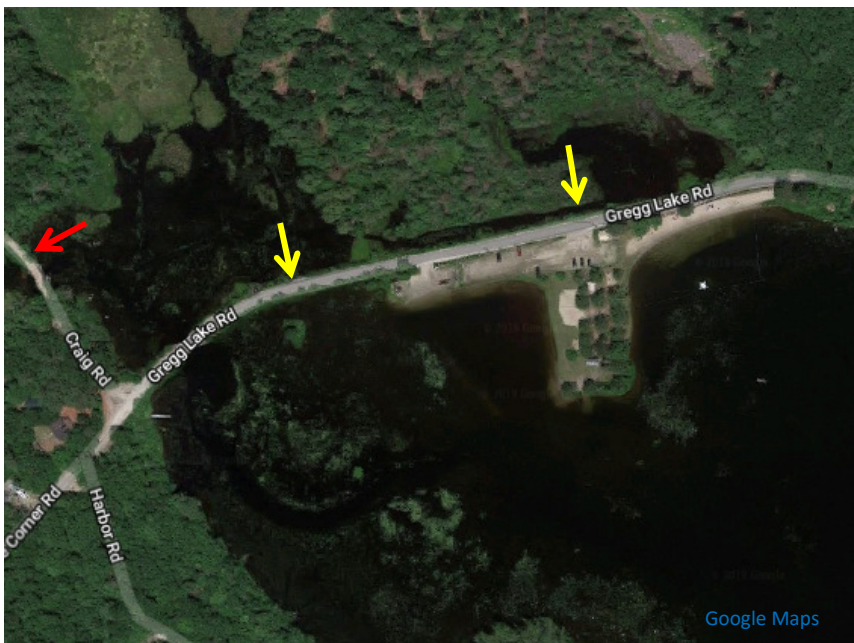
**Figure 5.7.** Overhead view of the causeway stretch of Gregg Lake Road, including the Town Beach and Boat Launch area. Arrows show locations of sinkholes that opened up along Gregg Lake Road (yellow) and Craig Road (red) in 2018.

The causeway stretch of Gregg Lake Road crosses what used to be a mowed wet meadow (Fig. 5.7). It appears that the causeway was first constructed around 1835, when the Gregg Lake dam was located at the mouth of the current outlet channel and lake water levels were several feet lower. Records of repairs and improvements are scant, and the composition of the causeway foundation is not known.

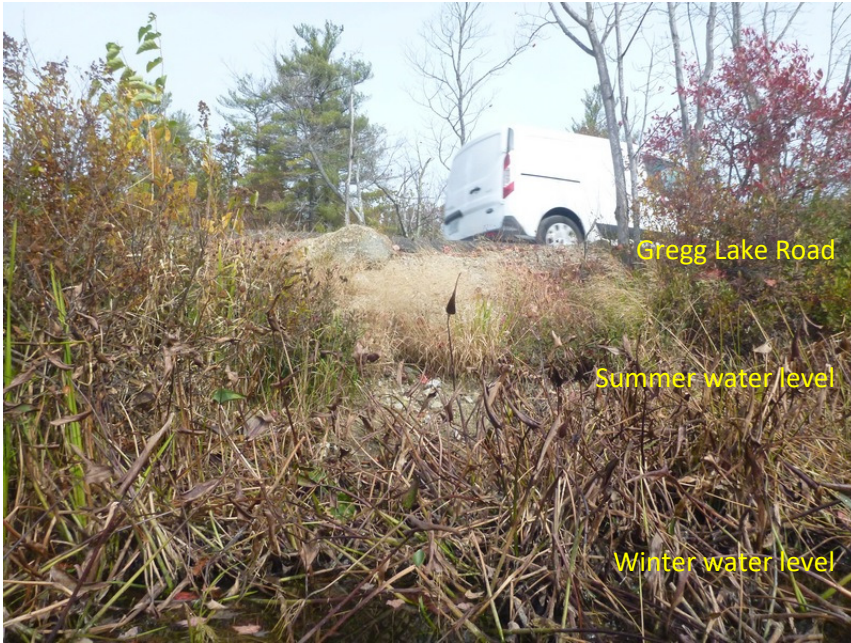
**Figure 5.8.** Loss of vegetation and erosion at steep causeway bank, visible at winter water level.

High water levels due to beaver dams, combined with the higher water levels maintained since the Gregg Lake dam was rebuilt in 1982, have led to unprecedented strain on both sides of the causeway. The lower sections of the steep banks on the south side of the causeway are eroding due to wave and water action (Fig. 5.8).

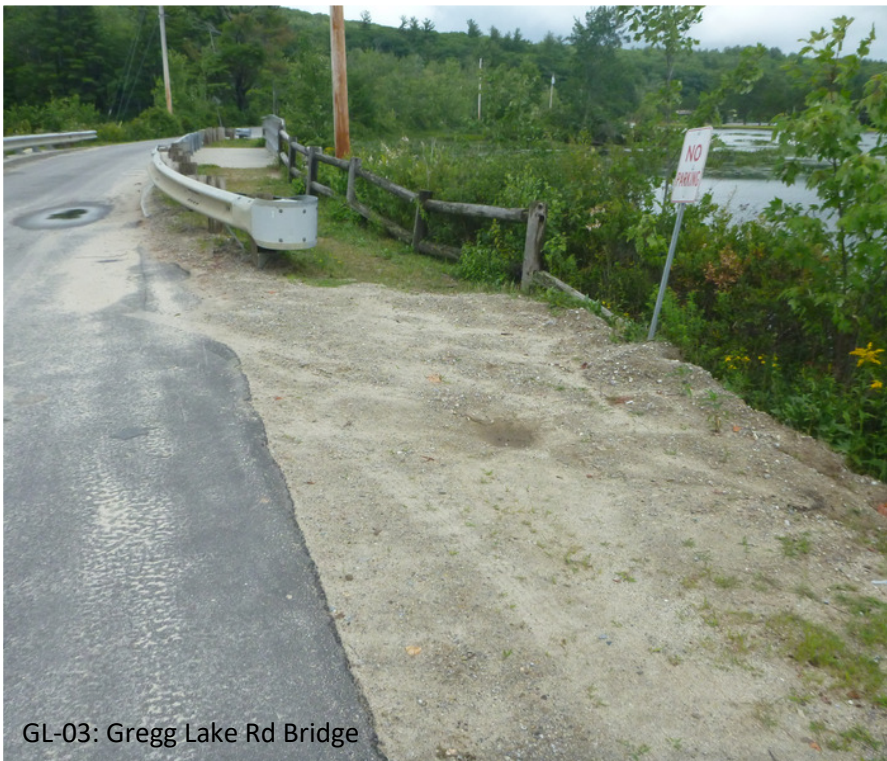
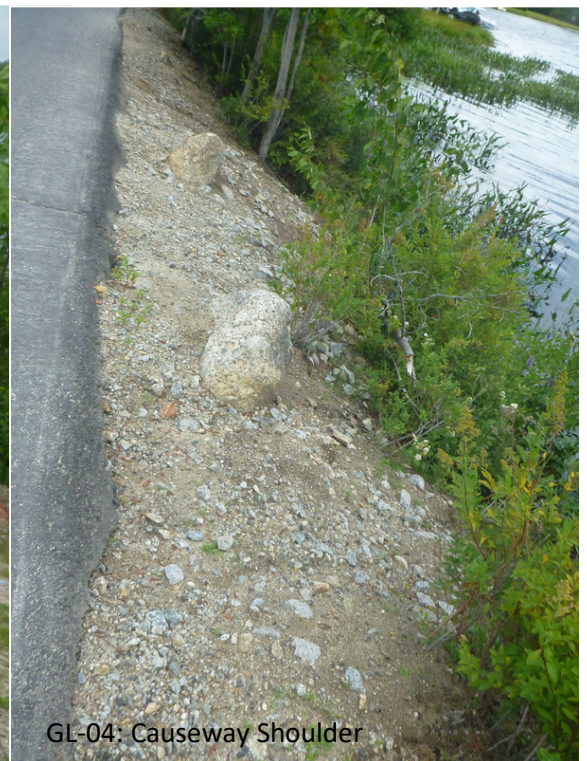
GL-03: Gregg Lake Rd Bridge

GL-04: Causeway Shoulder

**Figure 5.9.** Erosion Sites 03 and 04, showing bare shoulders and erosion of steep banks leading directly into Gregg Lake.

In addition, the shoulders require reinforcement and revegetation along much of the 1,300-foot causeway (Fig. 5.9). Private property borders the eastern 900 feet of the causeway on the north side; the rest of the property bordering the causeway is Town-owned.

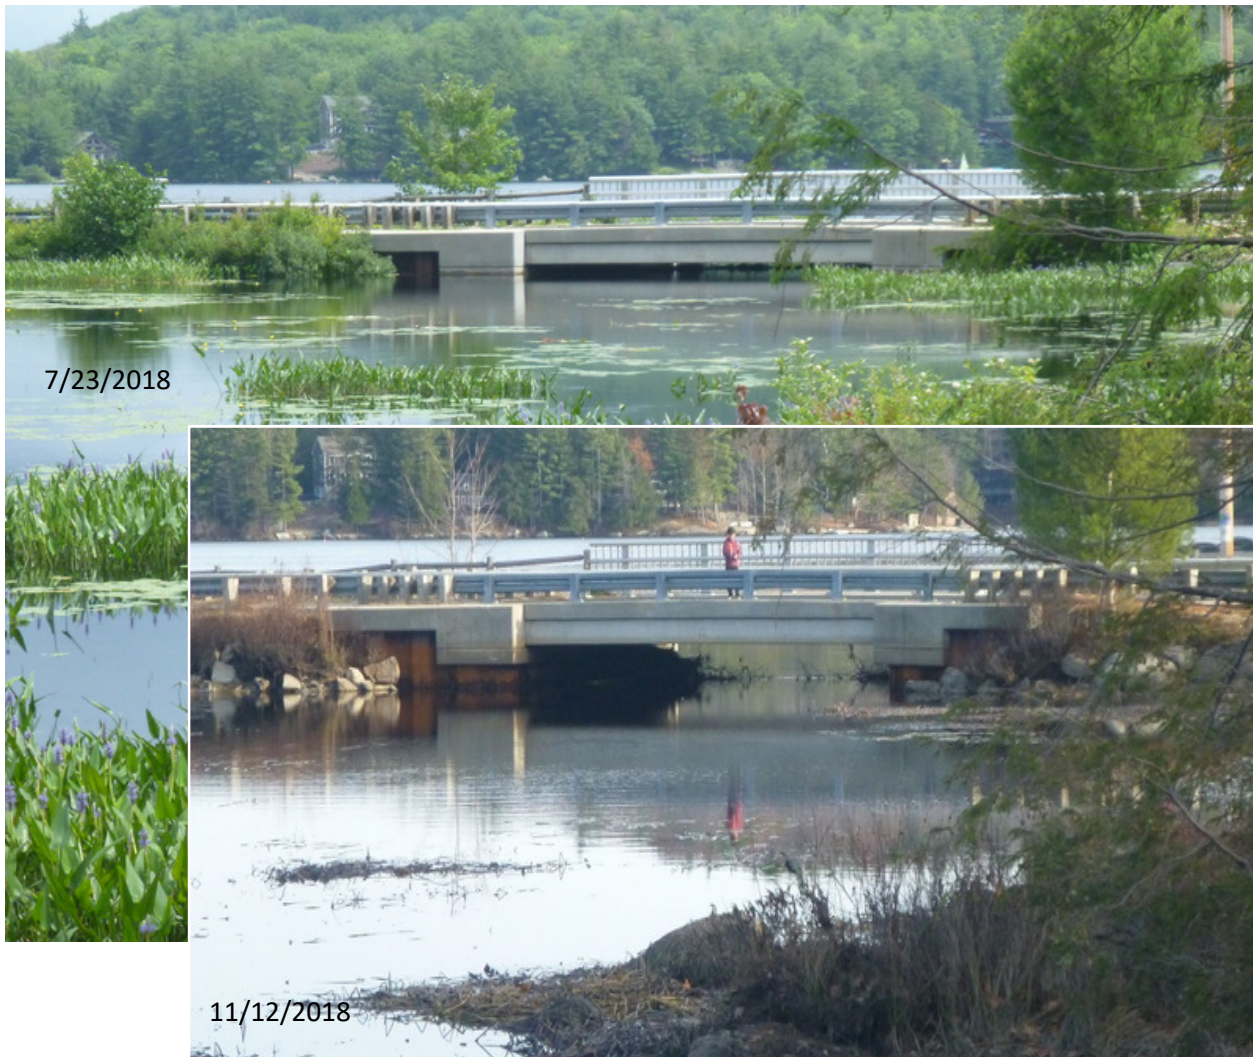
**Figure 5.10.** *The Gregg Lake Road bridge with the water on the north side of the beaver dam nearly touching the bottom of the bridge in Summer 2018, and in Fall 2018, following removal of the beaver dam.*

Beaver dams constructed under the Gregg Lake Road bridge have regularly filled the space under the bridge (Fig. 5.10). In 2018, the water was measured to be more than two feet higher on the northern (upstream) side than the summer lake level on the southern (downstream) side, and reached several inches over the bottom of the bridge.

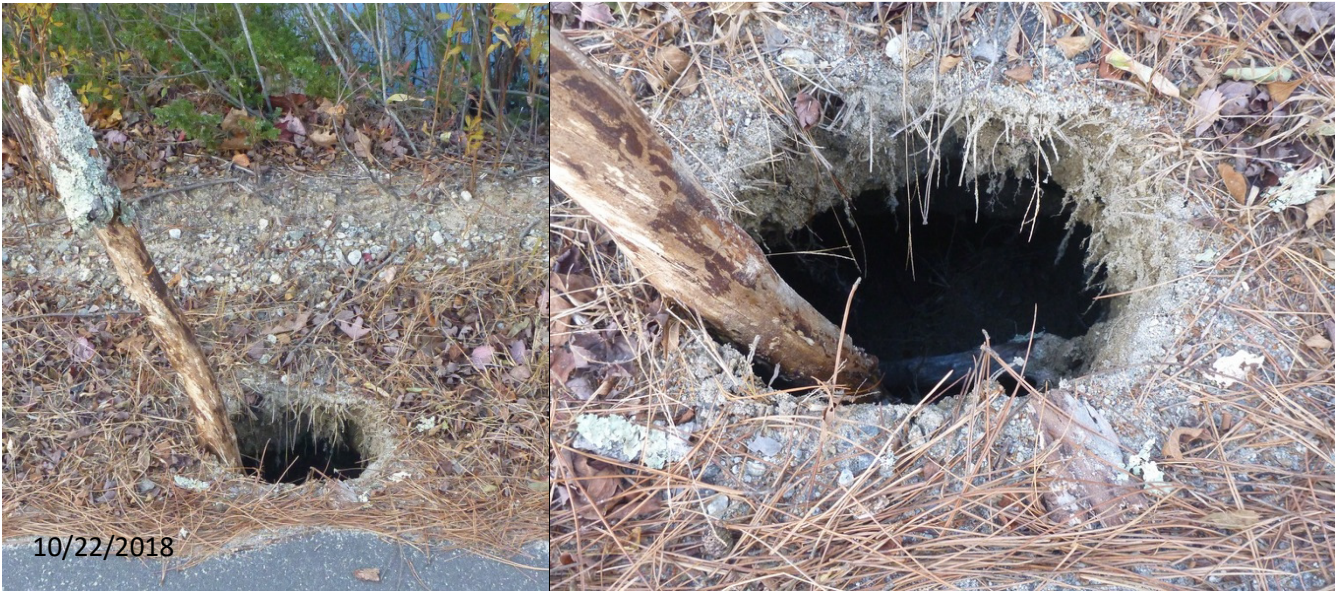
**Figure 5.11.** Sinkhole approximately 3 feet in diameter and 3 feet deep, with water visible at the bottom, found on Gregg Lake Road causeway Fall 2018.

In 2018, two sinkholes opened up on the north side of the causeway (locations shown in Fig. 9). One was likely at least partly responsible for a town truck falling into the water—the causeway shoulder collapsed when the truck tires left the pavement as two town trucks tried to pass each other. The second sinkhole was observed approximately a month after the truck incident (Fig. 5.11).

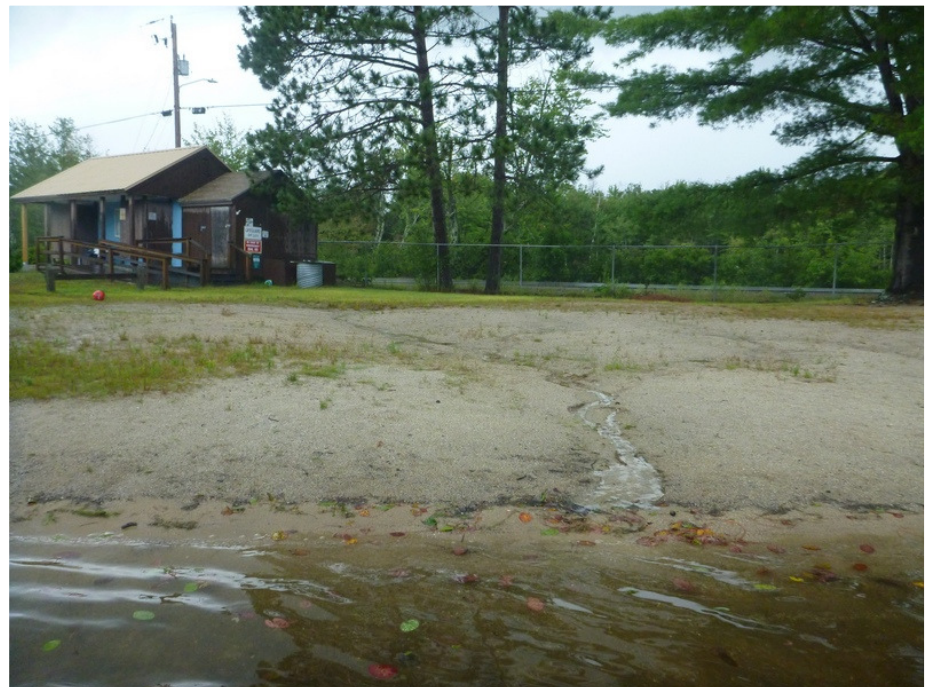
**Figure 5.13.** Drainage from Gregg Lake Road and the beach parking lot across the beach into Gregg Lake.

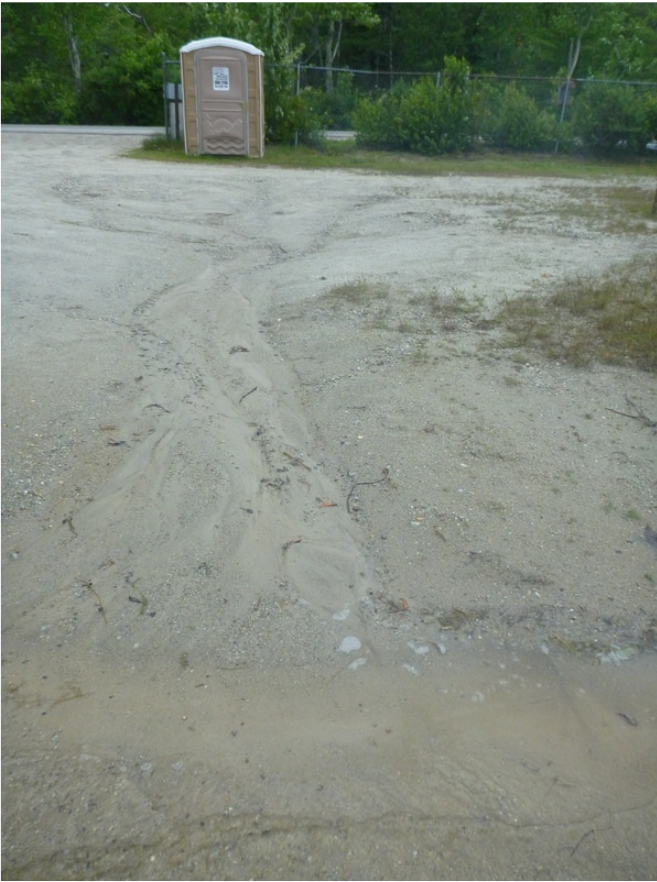
**Figure 5.14.** *Stormwater flow down the public boat ramp into Gregg Lake.*

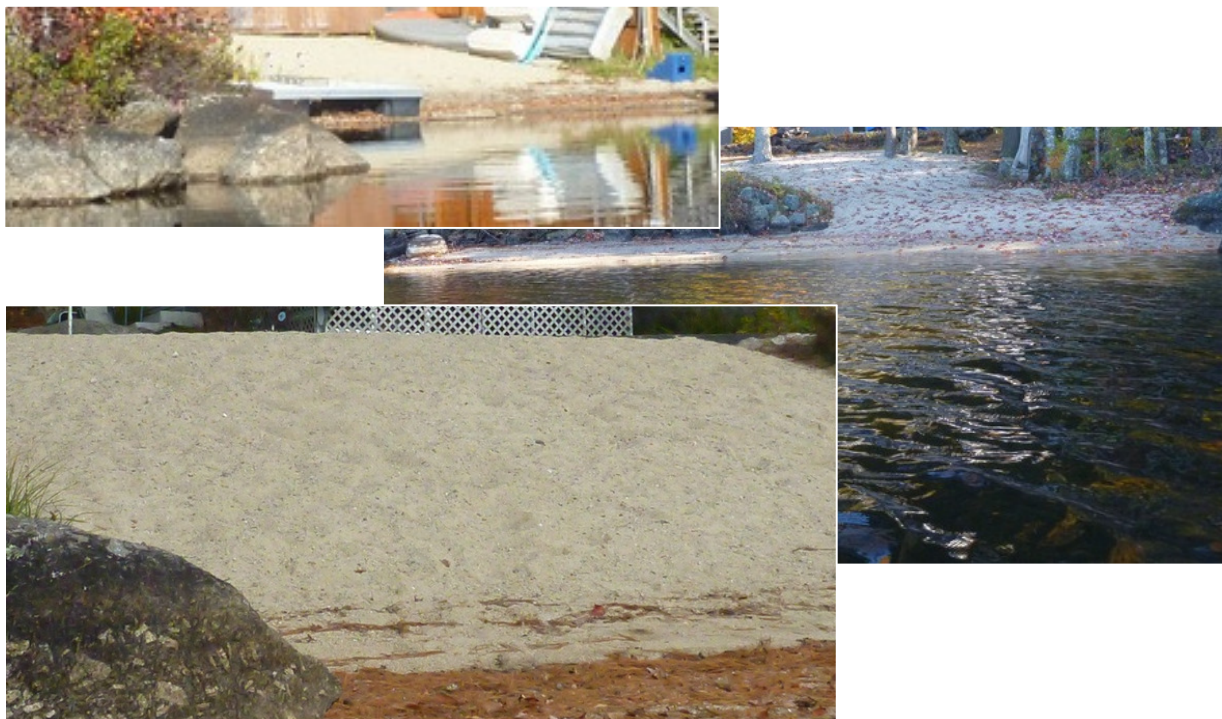
**Figure 6.1.** *Severe erosion sites where sand has been dumped recently to create beaches on Gregg Lake.*

Although shoreline surveys did not identify many severe erosion sites, there were several sites where practices do not adhere to shoreline protection guidelines, especially in the areas of dumping sand to create beaches and clearing vegetation from areas close to the shoreline. One site visible from Gregg Lake Road, where sand was dumped on the steep bank leading down to the shoreline, was rated by FBE as contributing 1.7 lb/yr of phosphorus and nearly 2 tons/yr of sediment loading (Fig. 6.1). Two analogous additional sites were found during the Fall 2019 shoreline survey, for a total phosphorus load of approximately 5.1 lb/yr—a substantial fraction of Gregg Lake’s phosphorus load that could be reduced through landowner education.

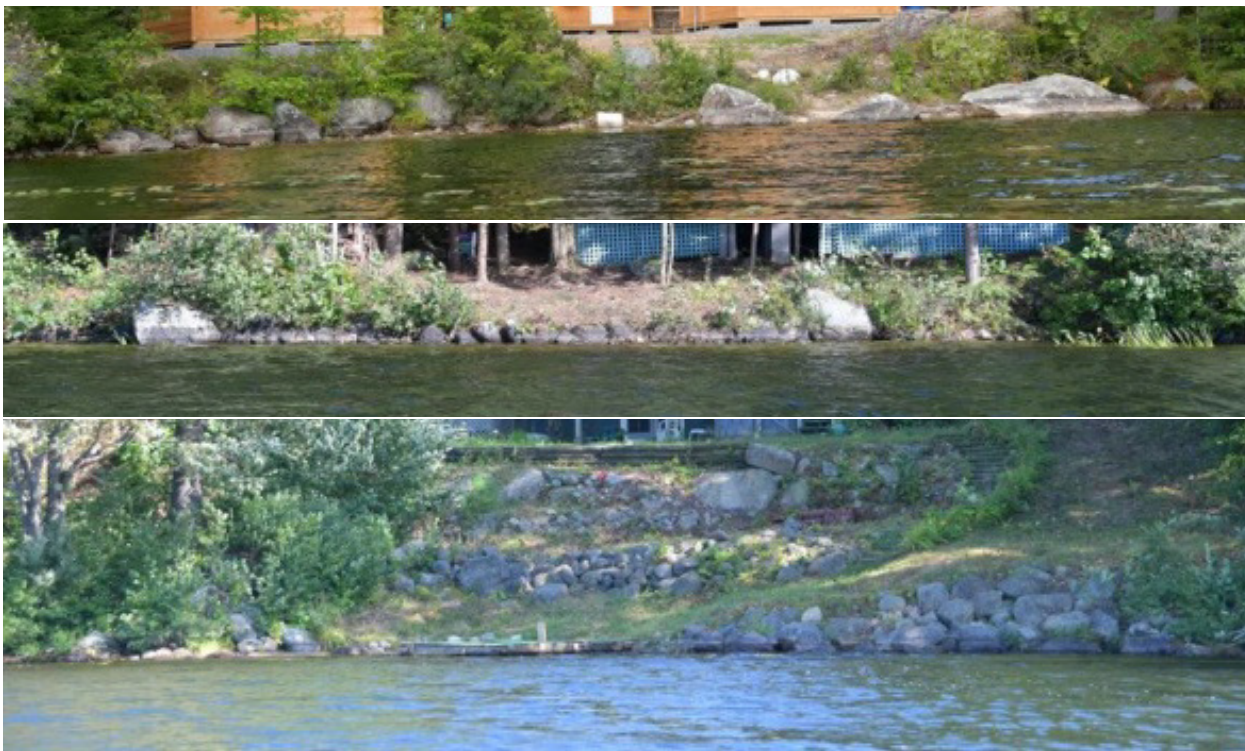
**Figure 6.2.** Examples of recent clearing, exposing shoreline to erosion at Gregg Lake.

There have also been several recent instances in which vegetation has been cleared to the shoreline (Fig. 6.2). Education to reach shoreline landowners about the effects of these practices on lake phosphorus and suspended sediments due to erosion and stormwater runoff should help to reduce the frequency of such practices.

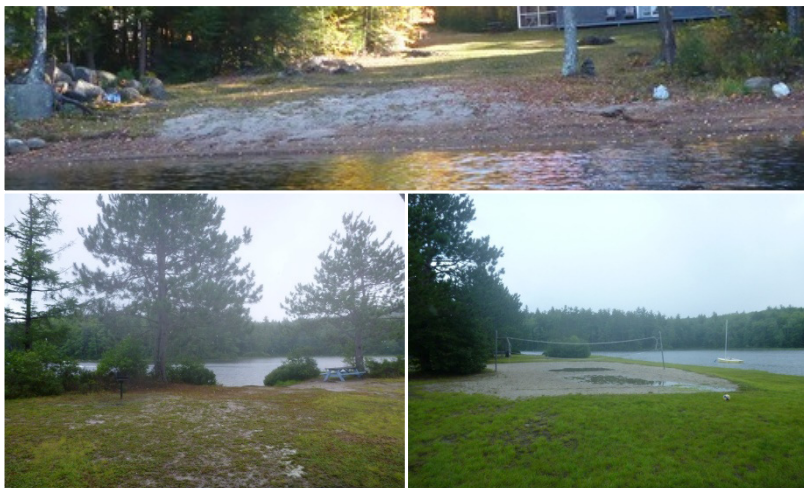
There are not too many properties around the perimeter of Gregg Lake with extensive areas of lawn, and few of these are treated with fertilizers or pesticides. However, shoreline property owners, including the Town of Antrim, will be encouraged to decrease expanses of lawn to make the lake less attractive to geese and limit erosion (Fig. 6.3). Lawn areas at the Town Beach are worn bare and eroding.

**Figure 6.3.** Lawn areas at Gregg Lake.

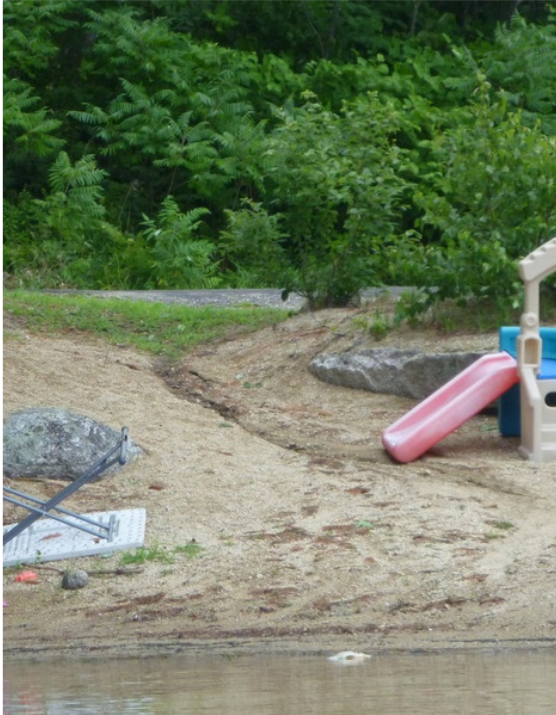
**Figure 6.4.** *Erosion Site 11, where runoff from Holt Hill Road flows across a private beach, carrying phosphorus and sediment into Gregg Lake.*

Many sites of erosion due to stormwater runoff are found around the lake shoreline (Fig. 6.4). A combined effort with the Town installing BMPs to reduce runoff from roads and private landowners managing land runoff and drainage from impervious surfaces will be required to achieve the necessary reductions in phosphorus and sediment.

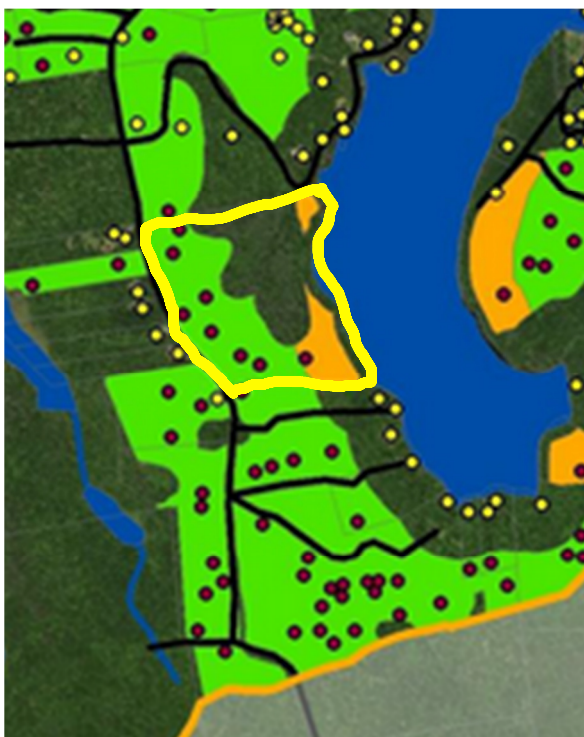
A second conservation easement was completed in 2019 on an undeveloped 57-acre lakefront property with approximately 2500 feet of shoreline (Fig. 7.2). The easement on this property will offset an estimated phosphorus load of 5.2 lb/yr by preventing construction of one house in the lakefront residential district and seven houses in the rural conservation district.

**Figure 7.2.** *Currently undeveloped 57-acre lakefront property with approximately 2500 feet of shoreline put under a conservation easement in 2019.*

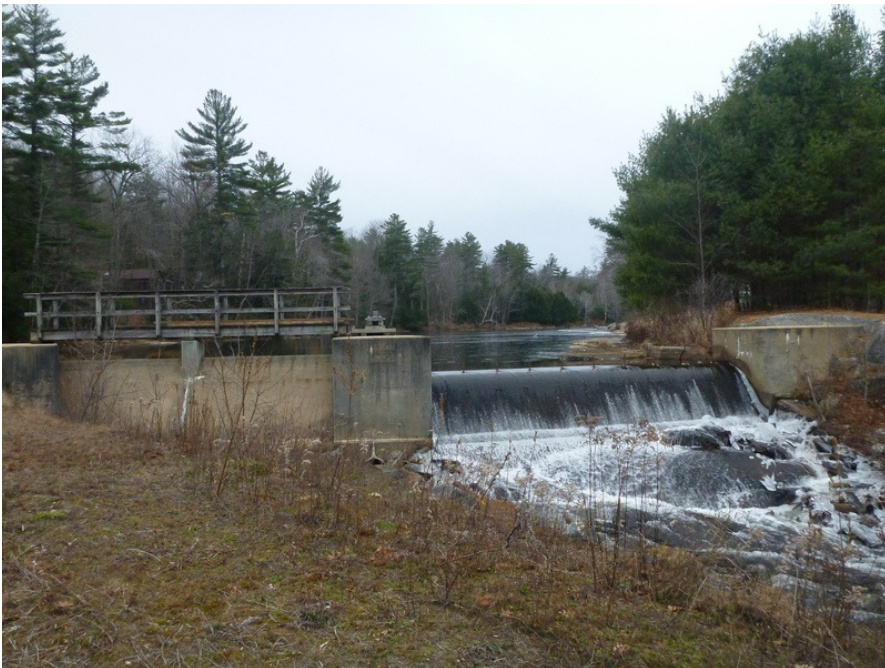
**Figure 8.1.** Gregg Lake dam, rebuilt in 1982, with no flashboards in place.

When the Gregg Lake dam was replaced in 1982 (Fig. 8.1), the water level was raised substantially above historical levels. The new dam was built to be used with three 8" flashboards in place in the summer months, but the third flashboard was quickly removed due to complaints that the water level was too high.
