# Gregg Lake Action Plan

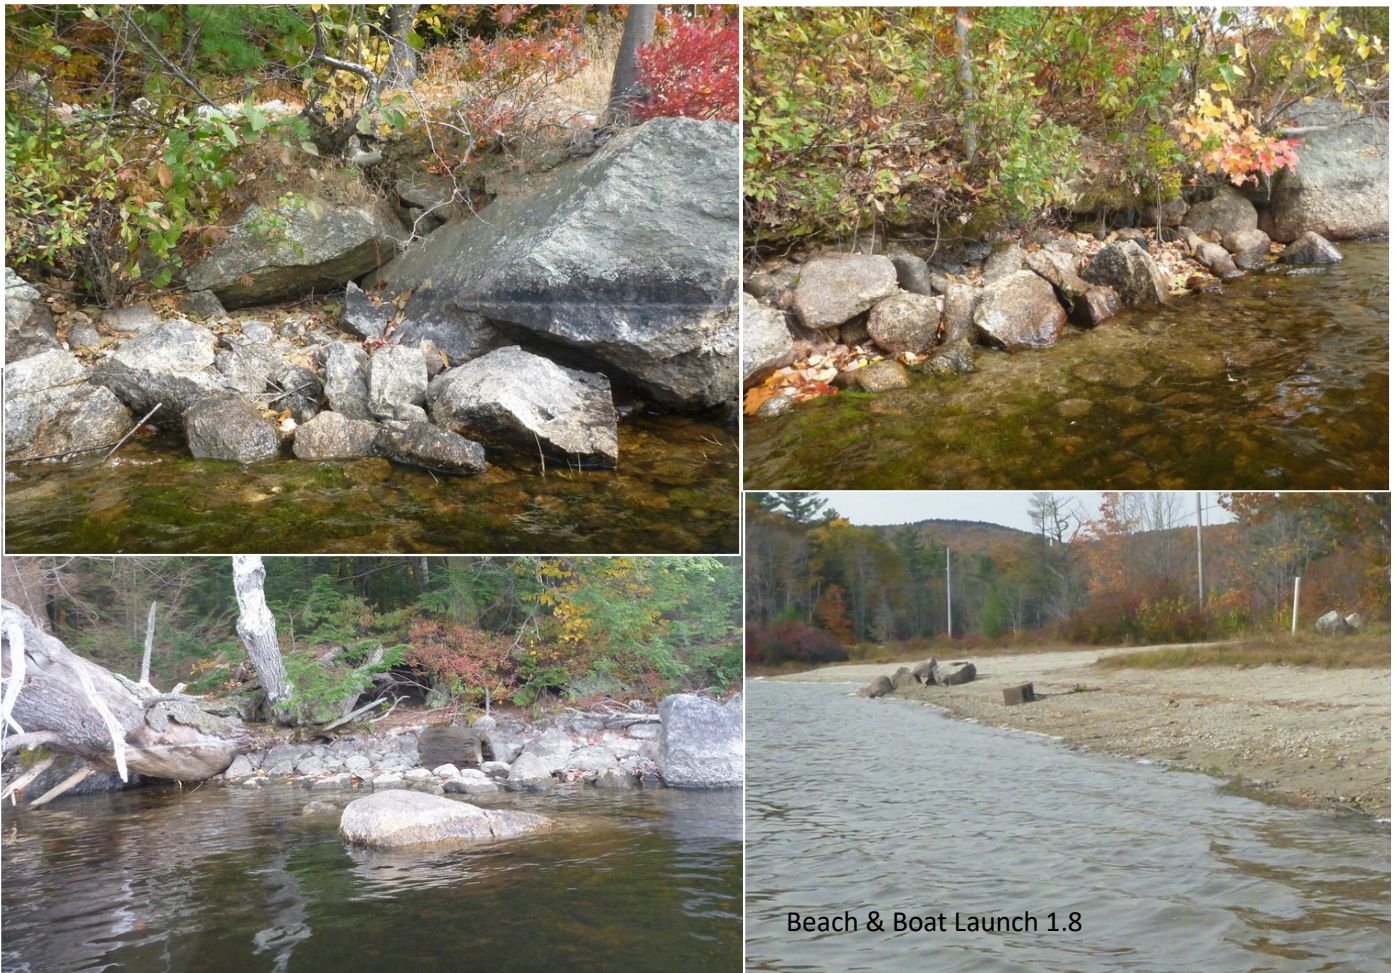
**Figure 8.2.** *Shoreline erosion on Gregg Lake, visible at winter water level.*

Since then, the dam has been operated with two 8" flashboards, and the lake has been establishing a new shoreline, with severe erosion along steep banks and recession of the shoreline in shallower areas (Fig. 8.2). Erosion along the steep banks of a 2,000-foot stretch of Gregg Lake Road is reaching a critical point, where the bank has been undercut in some places as much as three feet deep, reaching close to or under the road pavement (see Fig. 5.6). Wave and boat wake action at summer water level exacerbates the undercutting.
